# The Warner River Watershed Conservation Project Landowner Site Visit Report

Bassi Property  
Tributary of the West Branch  
904 Mountain Rd  
Bradford, NH  
43.26263N -72.03513W  
August 17, 2017

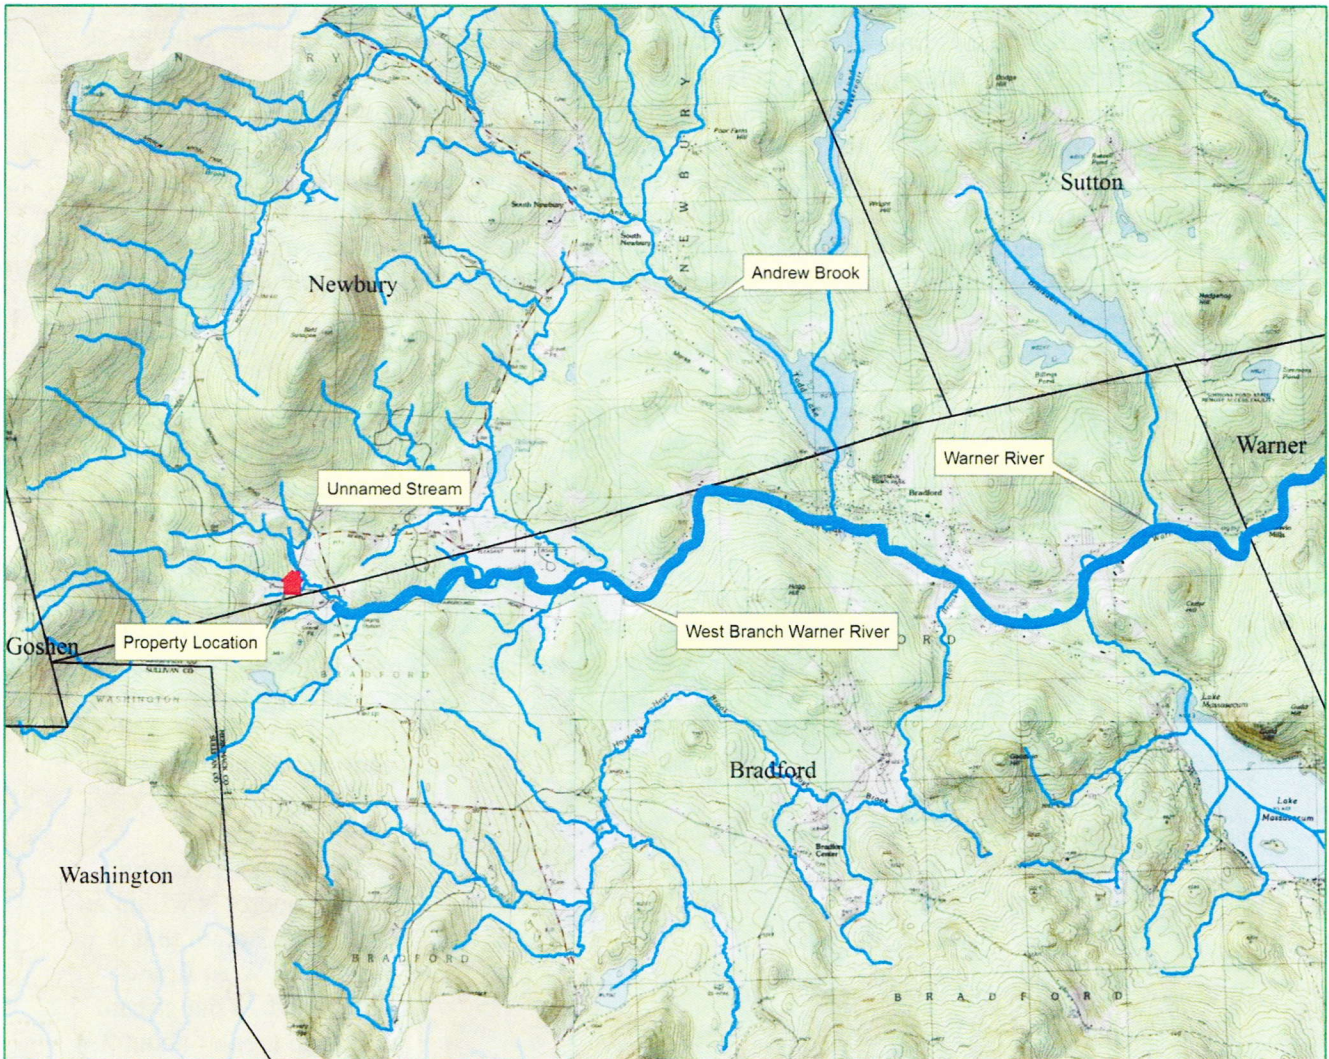
*Your stream drains both the eastern slopes of Mt. Sunapee as well as the southern slopes of Bald Sunapee. It joins several other streams near Box Corner and becomes the West Branch of the Warner River. South of Lake Todd, the West Branch joins Andrew Brook to become the Warner River. Your stream is one of the many cold water tributaries that support wild brook trout populations in the Watershed.*

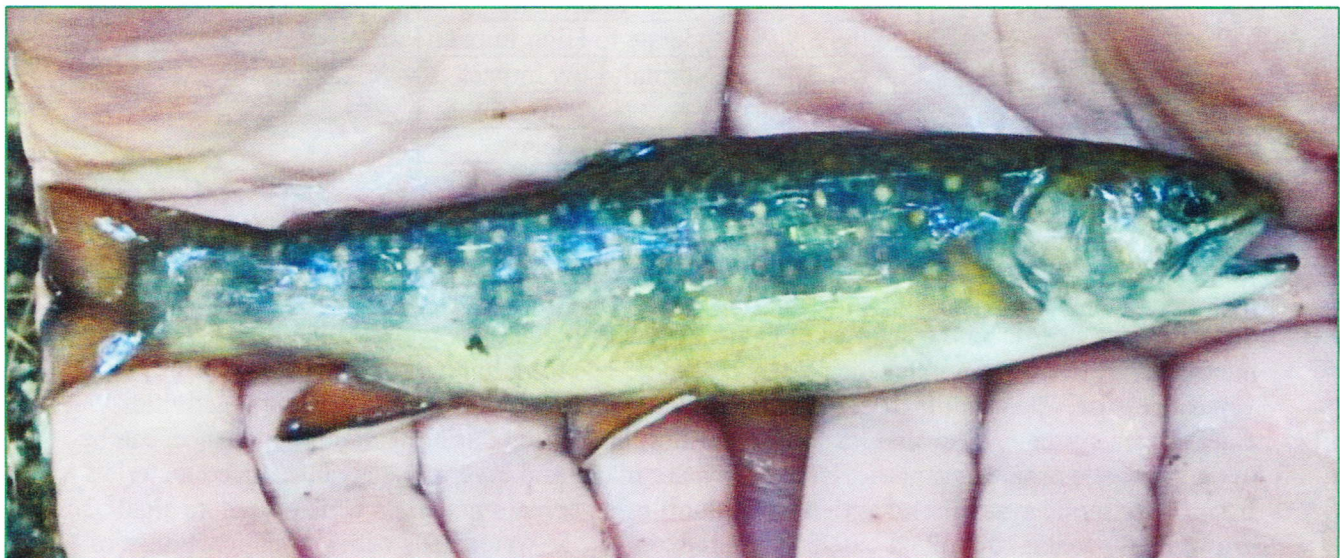
*An example of one of the 59 wild brook trout caught in the Unnamed Stream on your property.*

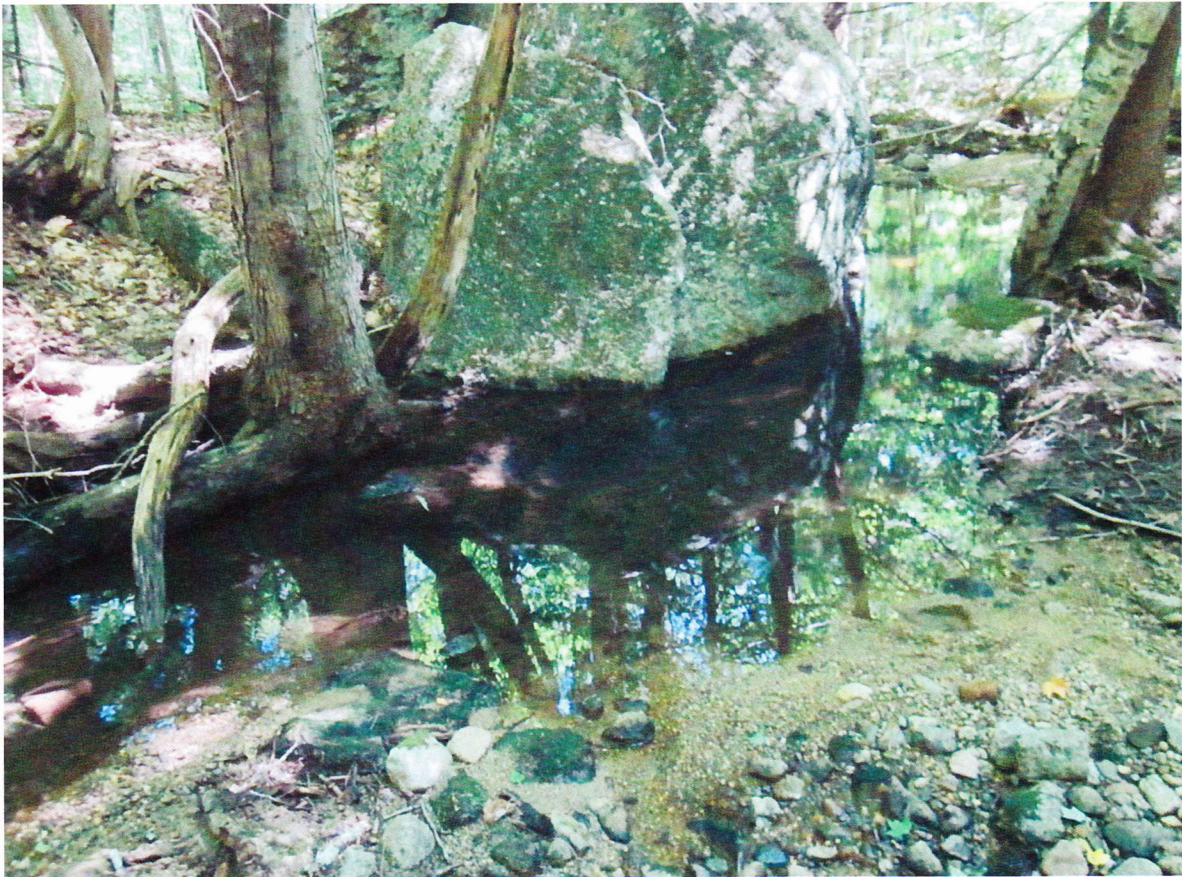
*This area held many trout as it provides a deep pool, undercut banks and gravel areas for spawning.*

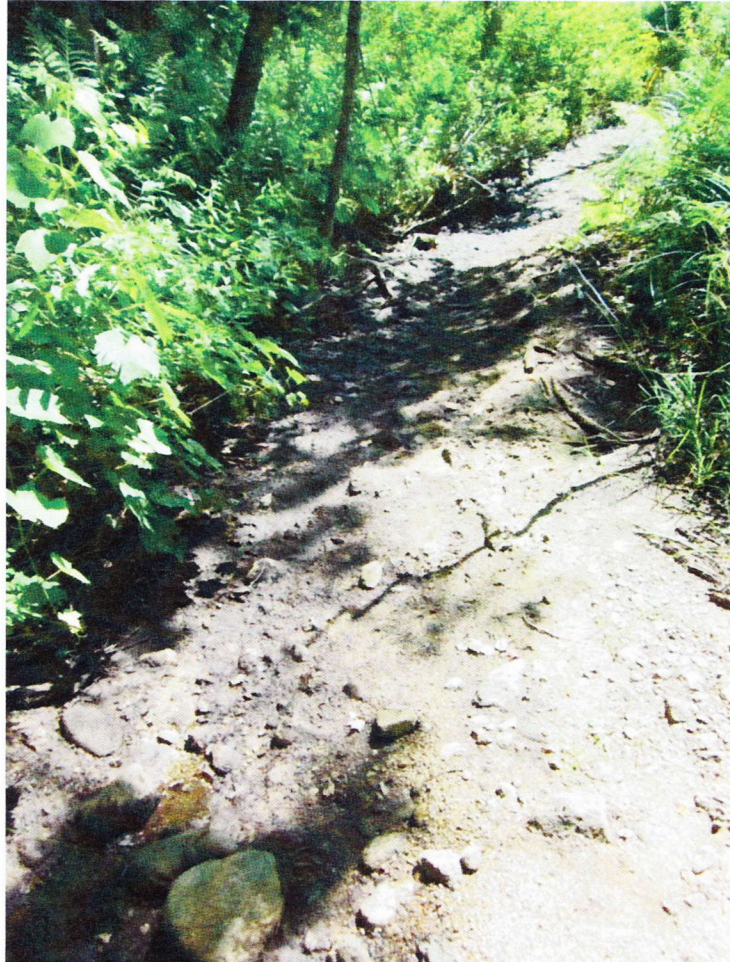
The primary concern noted during the site visit involves the southern (field side) riparian area of the brook. The desire to have views and open access is understood and appreciated. As more and more field is abandoned and reverts back to forests, we lose a component of habitat diversity.

*This area is “downstream” from our survey area and borders the open mowed field. Due to its southern orientation, it receives direct sun most of the day. Here is an example of where there’s an opportunity to restore the riparian area along the southern side of your stream. This riparian area should be able to reestablish on its own but this process can be accelerated by planting natural vegetation. This area creates a barrier to fish movement, stopping fish in the wetlands downstream from accessing this cold water refuge during the warm summer months.*

New Hampshire is currently around 87% forested, so losing field to forest can be seen as a real loss. Yet, in this particular location, allowing the riparian area to revegetate will address the direct sun the brook receives all day, the warming of the water and the disappearance of the stream completely for 200 feet. Reducing the mowing and increasing the forested cover in this area will increase the resiliency of the wild brook trout population. More mid-level bushes and shrubs will help maintain or enhance stream water temperatures by providing more shade. Although more of a long term strategy, by allowing the southern riparian area to revegetate with larger trees will eventually increase the amount of wood that falls into the brook. Wood that falls into a stream can help enhance stream characteristics and habitat by creating pools, trapping sediments and nutrients, promoting macroinvertebrate diversity, and providing overhead cover from predators. Larger wood material can help dissipate erosive flows by encouraging higher flows to the outside floodplains. Landowners may think that they are helping clean up a stream by removing woody material that falls in it. This is not the case. Any natural wood material (trees, sticks, even leaves) should be left to remain in streams because they provide

**Final Recommendations:** Curtail mowing of the lower field adjacent to the stream and allow the area to revegetate naturally. This direct sunlight has a significant effect on the disappearance of the stream as well as the temperature, movement barriers and connectivity of the stream. The old maple sugaring tubing could be removed from the stream and riparian area to improve the aesthetics of the stream.

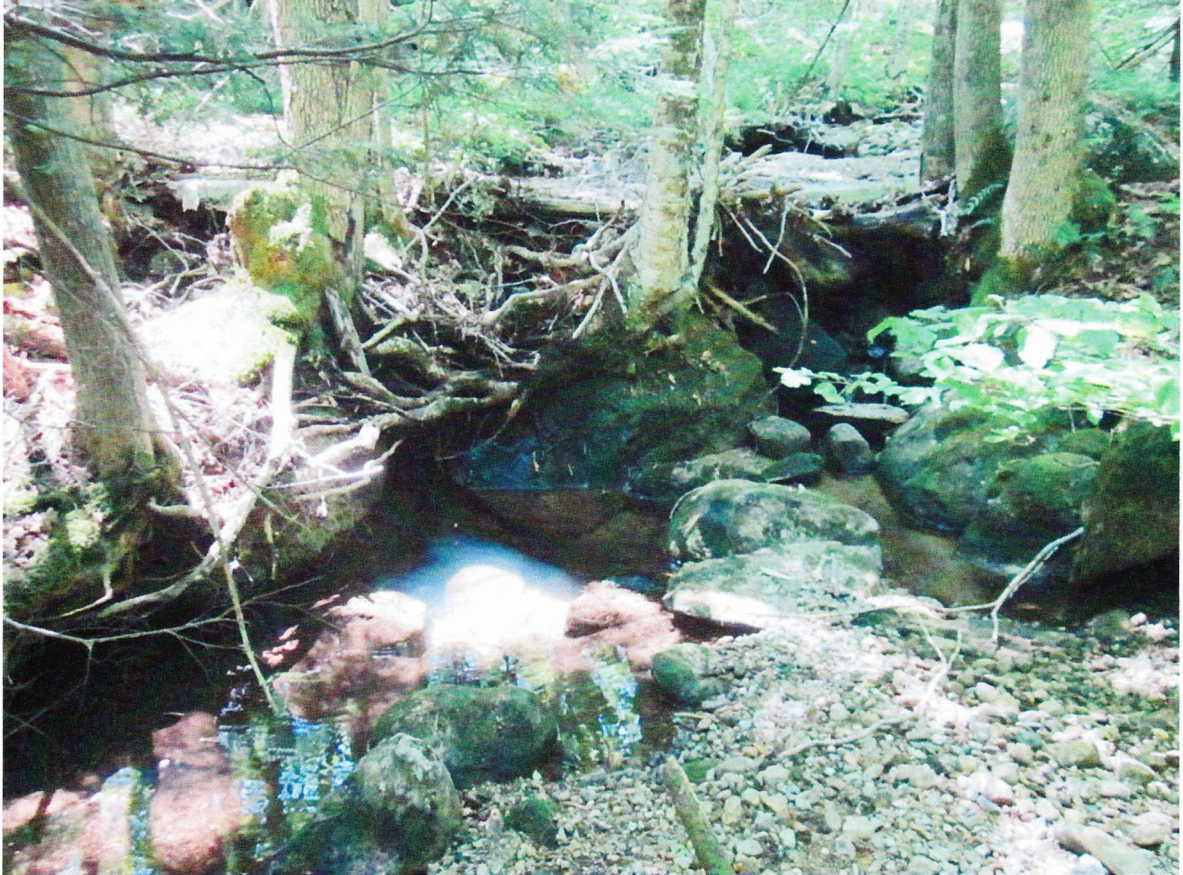
*Important habitat features can be created by fallen wood. Here, high flow events have accumulated wood behind the birch tree (center background). This helps dissipate erosive energy by pushing flows into the flood plain. Although fish may have a difficult time moving upstream from this wood jam, this impact is temporary and will eventually shift during another high flow event.*

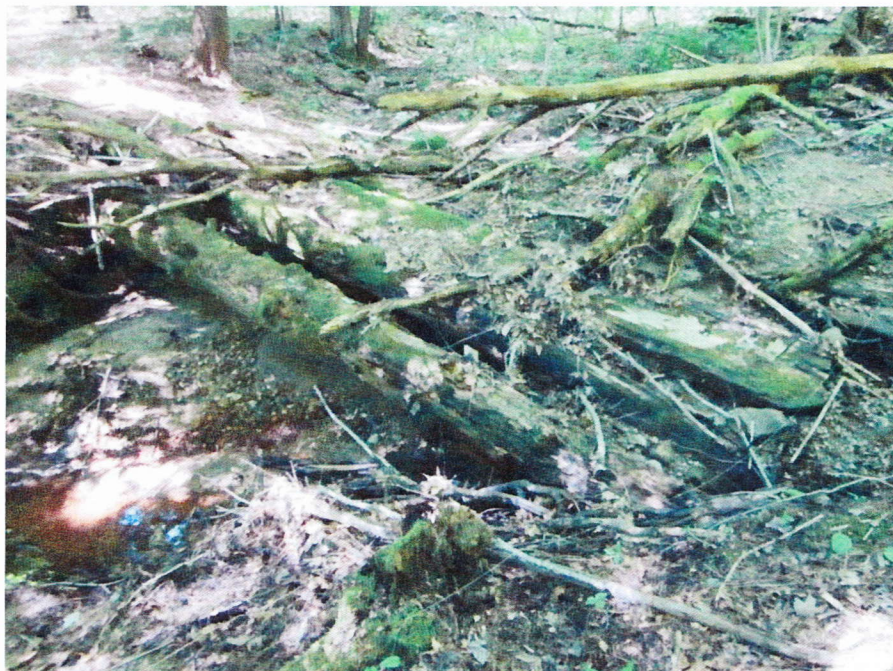
Although there were no culverts in our survey area, there is evidence of prior logging activity. This old log bridge has decayed and began to fall into the stream. It is not creating a barrier to fish movement and instead has benefitted the habitat by increasing the amount of large wood in the stream. These wood additions benefit the stream by slowing stream velocity upstream and depositing sediment, create habitat for macroinvertebrates and allows the stream to access the floodplain easier. Given the wood from the bridge is functioning as fallen trees, there is no immediate recommendation to remove this material.

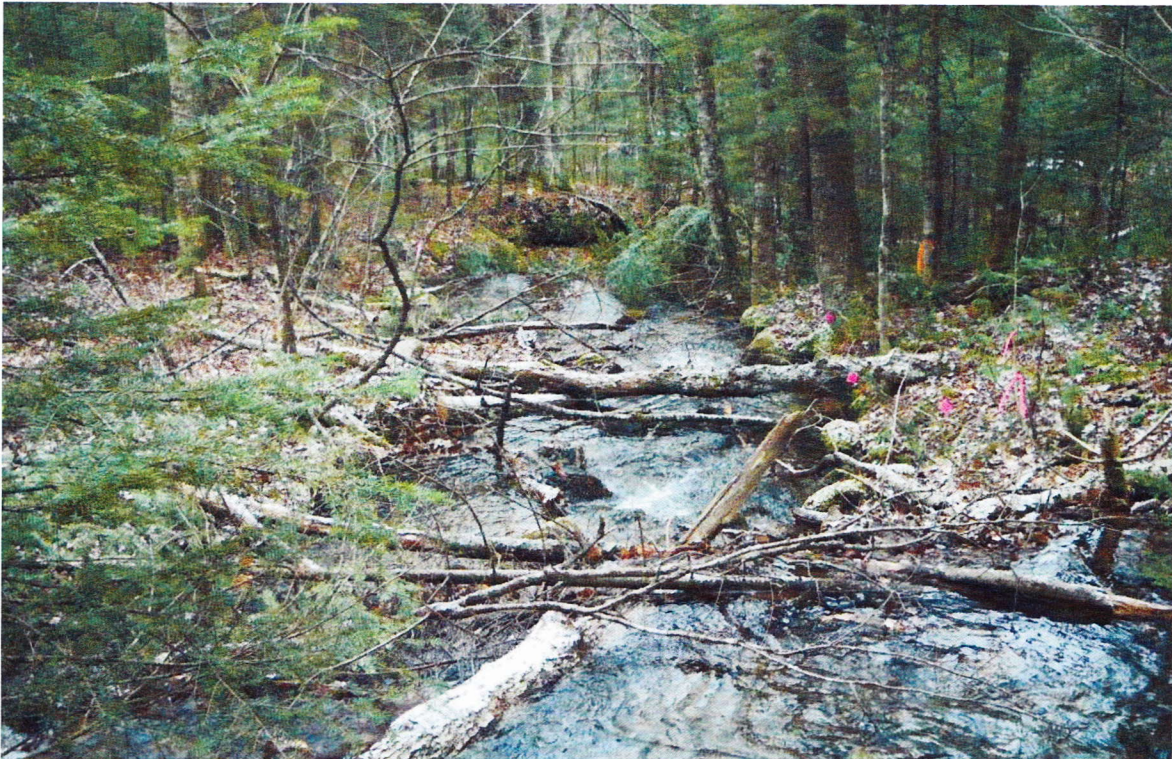
*Instream wood addition projects, such as this one performed in northern New Hampshire, provide habitat variety and protective cover for wild brook trout.*

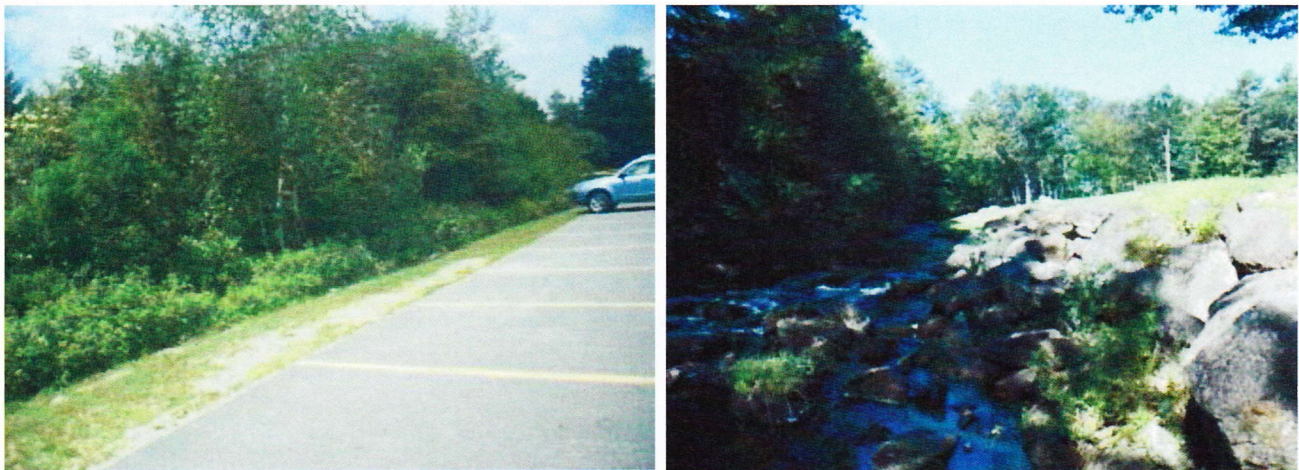
*Locations along an unnamed wild brook trout stream (left) and the Lane River (right), both in Sutton where riparian areas have been removed. The natural stream bank stability, filtering ability and shading of a stream has been reduced. Boulders have been placed overtime along this location of the Lane River to prevent damage to the adjacent field.*

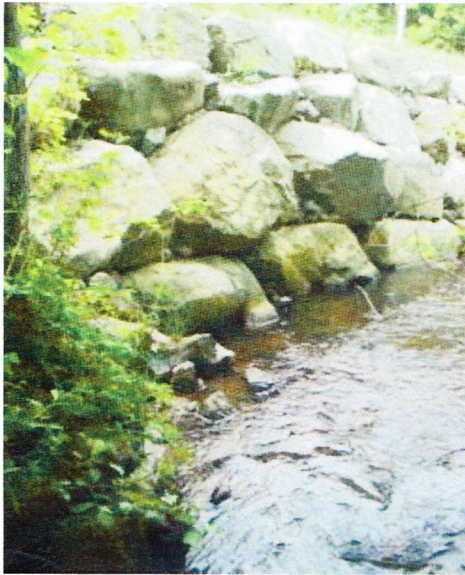
*Examples of shoreline bank armoring on Bartlett Brook in Warner (left) and Lion Brook (New London). During high flows, the stream is precluded from accessing its floodplain where the velocity of flows could be naturally reduced. Instead, erosive flows continue to downstream areas.*

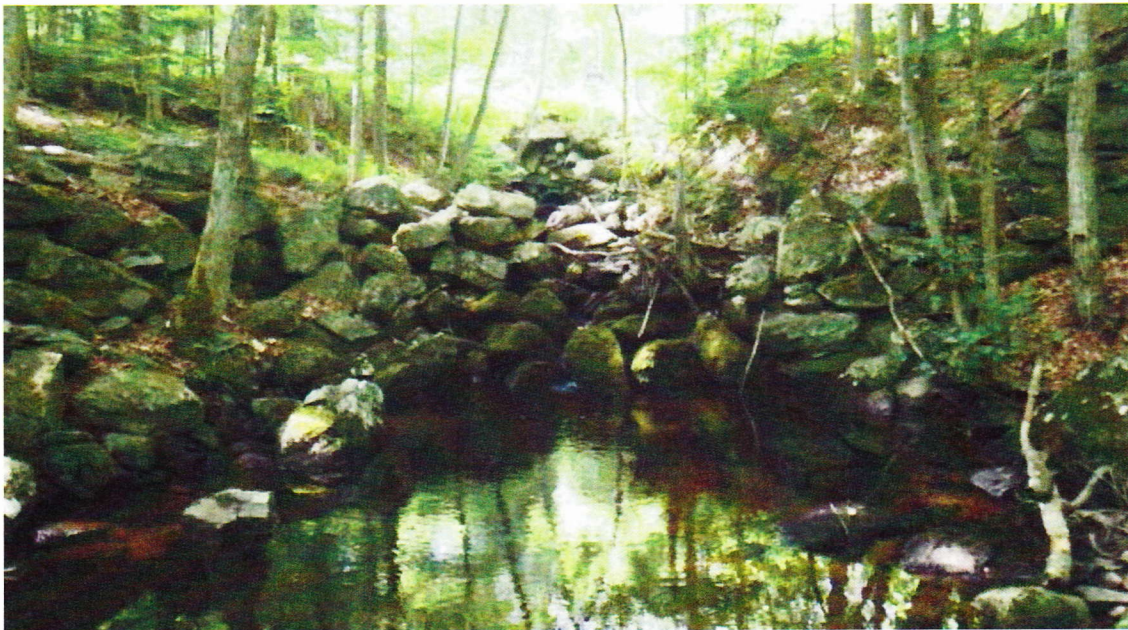
*Although this section of Ballard Brook in Warner now flows through a well forested canopy, the stonewall present here is a telltale sign of the land around the brook once being cleared for agricultural purposes.*

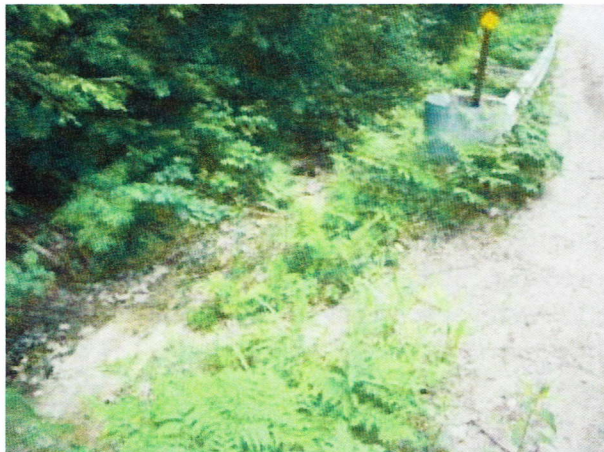
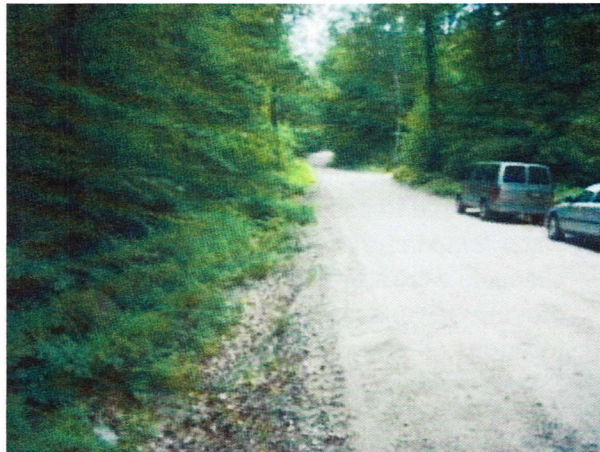
*Drainages directed into Silver Brook at the Mink Hill Lane crossing in Warner. In some cases, runoff management as shown here may compromise the integrity of the stream crossing structure. Sediments scoured from the gravel road are carried directly into the stream. These types of drainages should be directed away from the stream to prevent channel widening and impacts to fish and macroinvertebrate communities associated with sedimentation.*

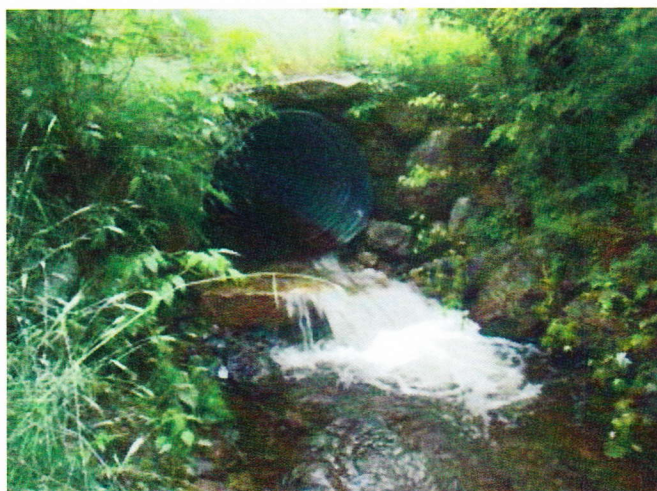
*Examples of undersized culverts on Kings Brook at Poor Farm Rd in Sutton (left) and an unnamed stream at Basin Hill Rd in Warner (right). Crossings not designed with the accommodation of fish passage and sediment conveyance make it difficult for fish to access more desirable habitats, increase erosion and sedimentation rates, and have an increased likelihood of failing.*
